PRODUCT  
SUPPORT  
BULLETIN # 197

6140 4-1/2" Sander/Grinder	Serial # 762-6472 thru 762-19796
6141 5" Sander/Grinder	Serial # 763-2001 thru 763-9720
6145 4-1/2" Sander/Grinder	Serial # 627-264027 thru 627-306417

**SUBJECT:** Armature & Field Burnout  
31-50-0425 Motor Housing

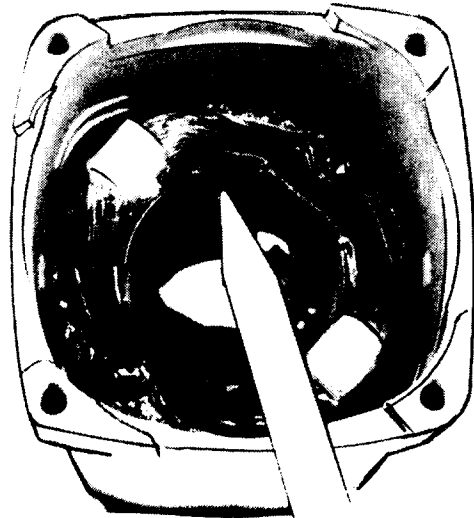
However, the problem may be the fit between the gear case and motor housing. An oversize motor housing gear case mounting area can exist, (*in the serial numbers ranges listed*) causing the fit between the gear case and motor housing to be loose; in turn allowing the armature to rub on the field and possible armature \ field burnout.

To determine a defective from non-defective 31-50-0425 motor housing, inspect the condition of the field laminations. If gear case mounting screws are tight and the field laminations show rub marks which are isolated to the upper portion of the laminations (see illustration), the motor housing should be considered defective and replaced at no-charge.

If the field laminations show rubbing through-out, the possible cause is either gear case or field mounting screws that loosened up and the motor housing should not be considered defective.
