**PRODUCT
SUPPORT
BULLETIN # 478**

TOOL(S) \ PRODUCT(S) AFFECTED: 5359-21 1-1/8" SDS Rotary Hammer

SUBJECT: SDS Plus percussion carbide-tipped bit not turning when put under load

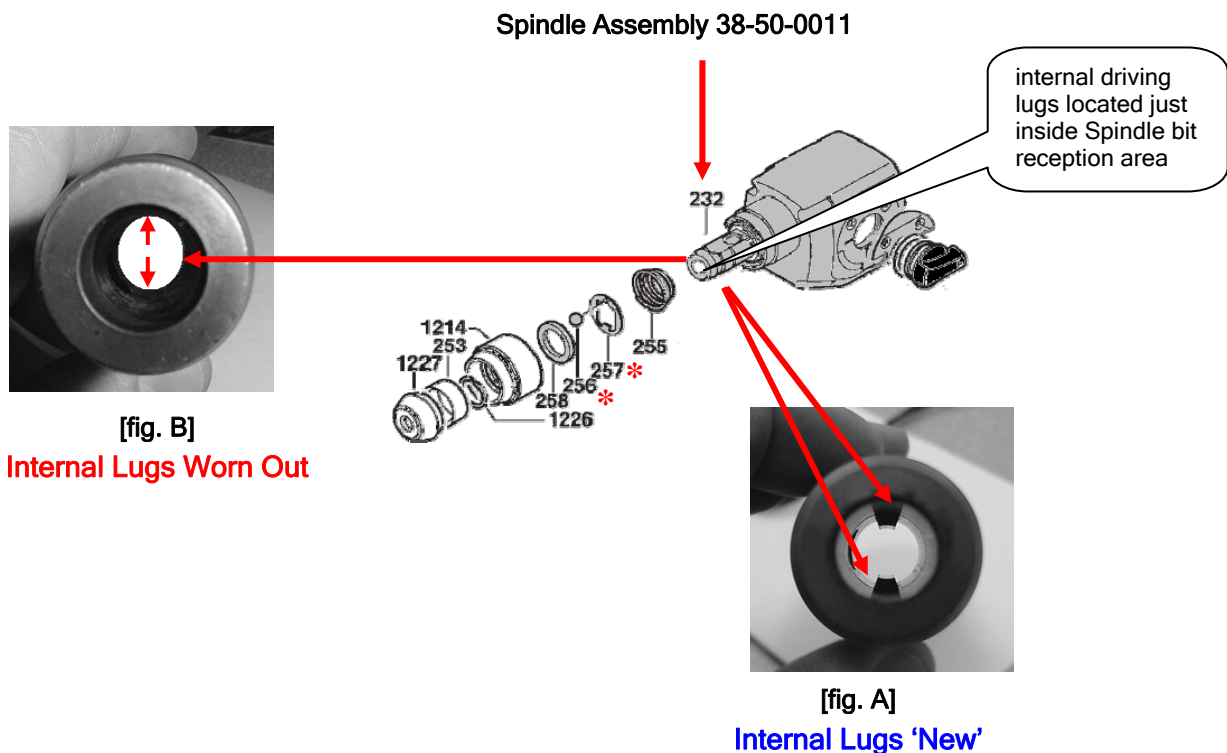
WEAR OUT of the internal driving lugs inside Spindle Assembly 38-50-0011 [fig. A] after many hours of use can / will occur. When servicing a 5359-21 Rotary Hammer always inspect / check the two (2) internal driving lugs for excessive wear / wear out. If the internal driving lugs are completely worn out as shown in [fig. B] the only thing holding and driving the bit / chisel stationary inside the spindle will be the support plate [fig. 257] and steel ball [fig. 256]. This alone is sufficient enough to hold but NOT drive an SDS Plus percussion carbide-tipped bit when drilling; the 38-50-0011 spindle assembly must be changed.
