**PRODUCT  
SUPPORT  
BULLETIN # 503**

**TOOL(S) \ PRODUCT(S) AFFECTED:** 2610-20 M18™ ½" Driver/Drill; 2611-20 M18™ 1/2" Hammer-Driver/Drill; 2629-20 M18™ Band Saw; 2650-20, 2651-20, 2652-20 M18™ Impact Driver; 2662-20, 2663-20 M18™ 1/2" Impact Wrench, 2664-20 M18™ 3/4" Impact Wrench, 2665-20 M18™ 7/16" Impact Wrench

**SUBJECT:** 'loss of speed' 40-50-2170 RH Brush Spring, 40-50-2175 LH Brush Spring

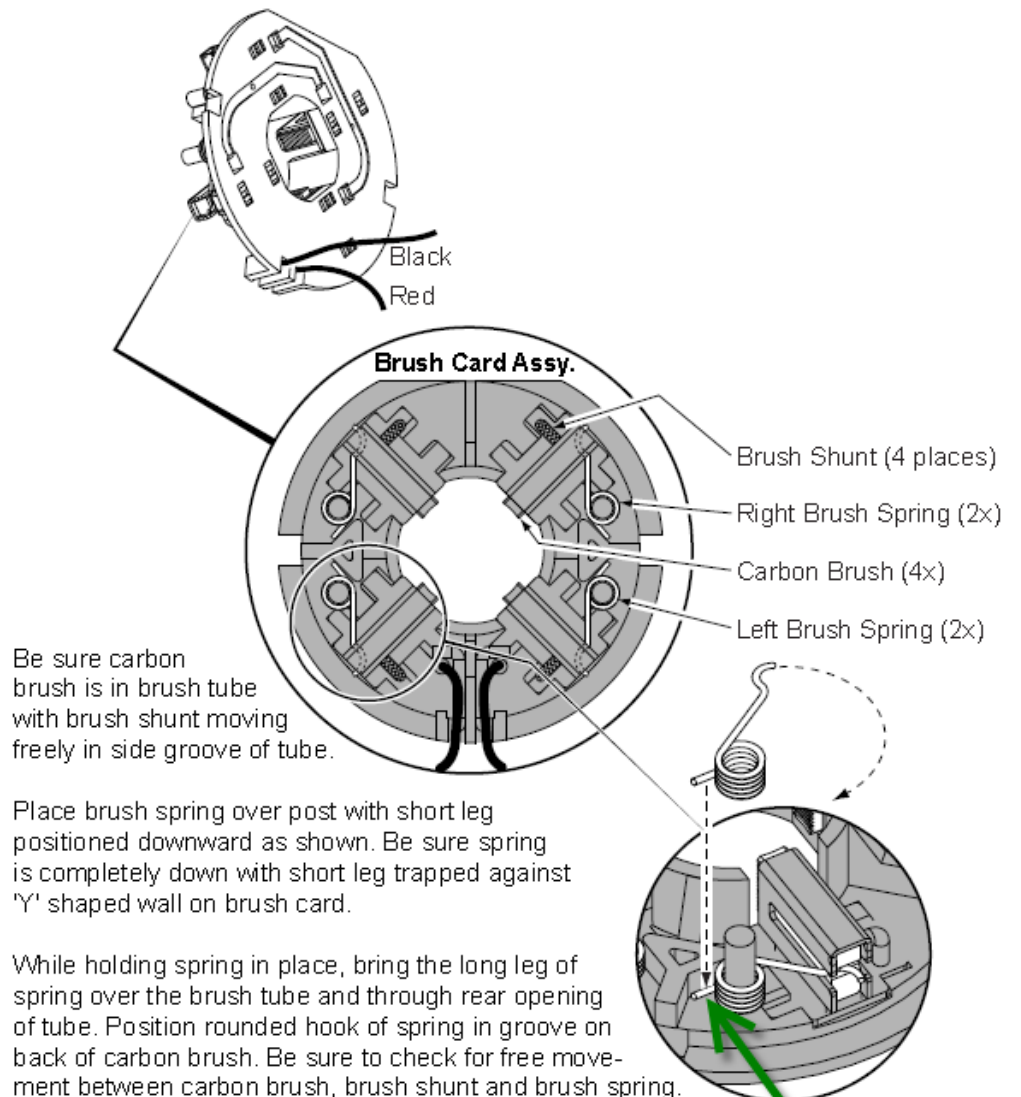
**WRONG**

**CORRECT**

Short leg of spring to the bottom

Replacement of both the RH 40-50-2170 & LH 40-50-2175 Brush Springs of the tool's Brush Card Assembly is recommended on tools which display a loss of speed. Please follow the instructions shown for proper installation of the brush springs.
