**PRODUCT
SUPPORT
BULLETIN # 344**

5460, 5540 7" / 9" Polisher

SUBJECT: Armature 'rubbing / dragging' on Field

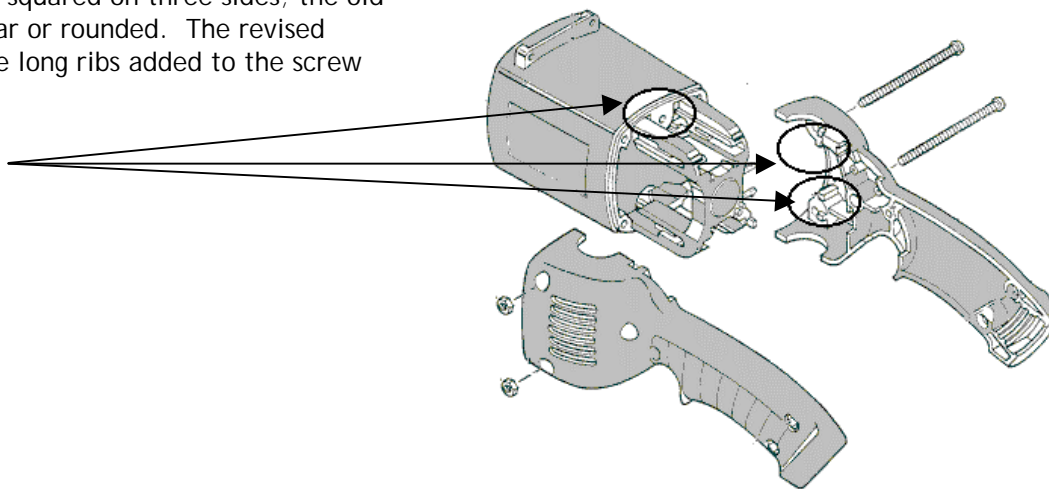
Affected areas —

A occasional complaint of a 5460, 5540 7" / 9" Polisher with it's Armature 'rubbing / dragging' on the Field laminations is caused when the two handle screws closest to the motor housing are tightened down; this distorts the motor housing allowing for the possibility of the armature & field to come into contact with each other.

The field screw-mounting pads of the revised motor housing are squared on three sides; the old version was circular or rounded. The revised handle halves have long ribs added to the screw hole area.

31-50-0548 Motor Housing, along with the **31-44-1771** Left Handle Half & **31-44-1776** Right Handle Half have been revised and have had ribs / material added. The added material prevents the twisting of the motor housing and eliminates the problem when the two handle screws are tightened.

Both a 31-50-0548 Motor Housing & the Handle Halves 31-44-1771 & 31-44-1776 need to be replaced to properly correct the problem.
