DATE: June, 2001

TOOL(S) \ PRODUCT(S) AFFECTED

9070-20, 9071-20, 9075-20 1/2" Impact Wrench manufactured between March and June, 2001

SUBJECT: 31-17-0265 Cord Clamp - Cord Field Lead wire connector disconnected

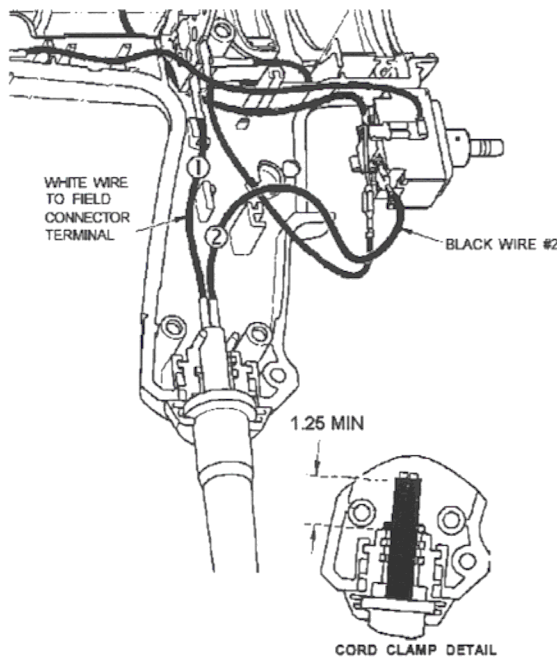
Service Note: A tool received with White Cord - Field lead wire / Field connector being disconnected is an indication of cord moving in the clamp.

As an aid in determining the cord clamp in a tool, the 31-17-0270 Cord Clamp has the numbers '0270' molded into the clamping rib. The 31-17-0265 Cord Clamp has no markings on the rib.

To improve cord retention in 9070-20, 9071-20, 9075-20 1/2" Impact Wrench original equipment 31-17-0265 Cord Clamp is being replaced by 31-17-0270 Cord Clamp.

Wiring specification has been modified increasing the length of cord inserted through the strain relief, cord clamp and into the handle from .25" pass top of cord clamp to 1.25" [see illustration].
