**PRODUCT
SUPPORT
BULLETIN # 370**

9070-20, 9071-20, 9075-20 Impact Wrench, sold between March, 2001 & June, 2001

SUBJECT: - PRODUCT SAFETY -

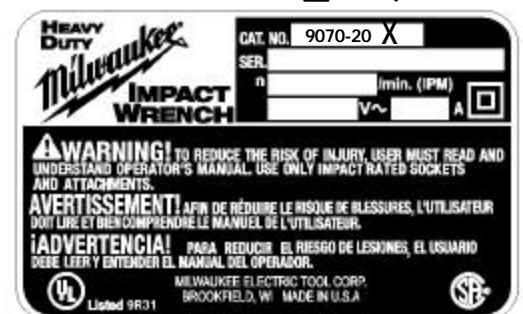
As an aid in determining the cord clamp in a tool, the 31-17-0270 Cord Clamp has the numbers '**0270**' molded into the clamping rib. The 31-17-0265 Cord Clamp has no markings on the rib.

Note: cord clamp assembly of the Impact Wrench is a two piece design, consisting of a 31-17-0260 Cord Clamp with posts [see illustration] assembled in the Left Handle Half and the 31-17-0270 Cord Clamp assembled in the Right Handle Half. [Check for proper repair, tugging on the cord after assembly will insure the cord clamp assembly is correct and that the cord set does not easily pull through the clamp.]

To improve cord retention in a 9070-20, 9071-20, 9075-20 Impact Wrench original equipment 31-17-0265 Cord Clamp is being replaced by **31-17-0270 Cord Clamp**. The 'clamping rib' of a **31-17-0270 Cord Clamp** is slightly larger and offers improved holding of the cord in the handle.

Stamp or etch an '**X**' on the tool's nameplate next to the catalog number after installation of a replacement **31-17-0270 Cord Clamp**.

The '**X**' will show that the impact wrench has been repaired.
