PRODUCT  
SUPPORT  
BULLETIN # 408

TOOL(S) \ PRODUCT(S) AFFECTED: 1680-20 1/2" Super-Hawg® Drill

**SUBJECT: 23-66-2360 reversing switch failure - 42-38-0280 Rocker Boot**

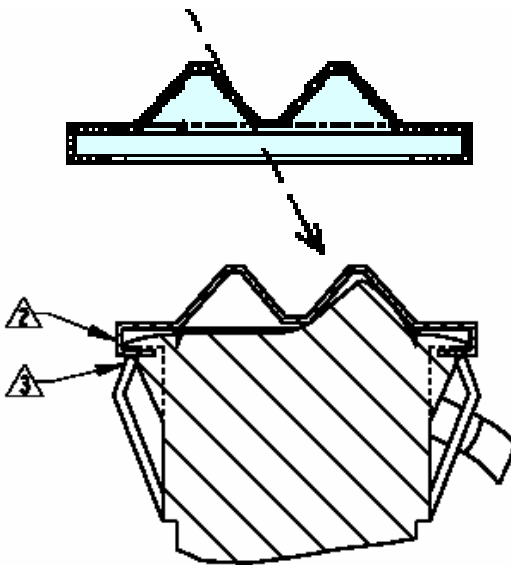
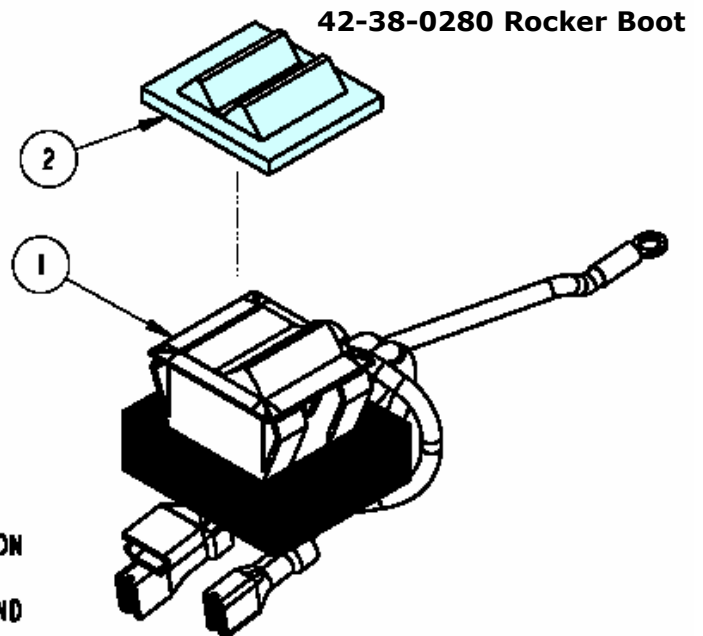
Failure of a Super-Hawg® Drill's 23-66-2360 Reversing Switch Assembly can generally be traced to wood fibers entering the switch body and causing it not to work in one direction or the other. Rocker Boot 42-38-0280 is being added to seal off the reversing switch, preventing contamination from causing switch failure.

42-38-0280 Rocker Boot should be placed 'on' the face of a 23-66-2360 reversing rocker switch when any service is done on a 1/2" Super-Hawg® Drill's switch without a Rocker Boot as standard equipment.

1. PLACE ROCKER BOOT OVER SWITCH IN ORIENTATION AS SHOWN.
2. HOOK LIP OF BOOT OVER LEDGE OF SWITCH AROUND ENTIRE PERIMETER OF SWITCH.
3. BOOT MUST BE FULLY SEATED UNDER ALL 4 SWITCH TABS.
